AIRBAG INVESTIGATION

CASE NO. 93-05

TECHNICAL REPORT

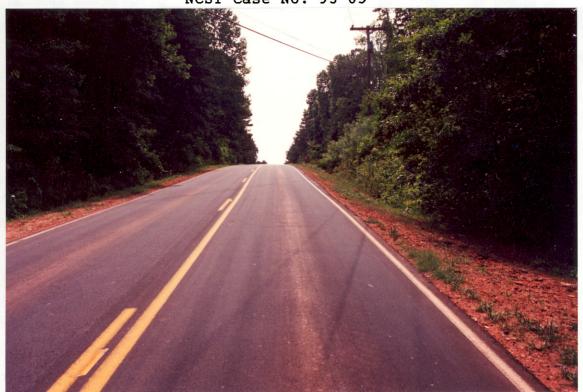
1. Pre-impact travel path of the 1991 Mercury Capri convertible (airbag equipped vehicle) east on Road in Georgia.

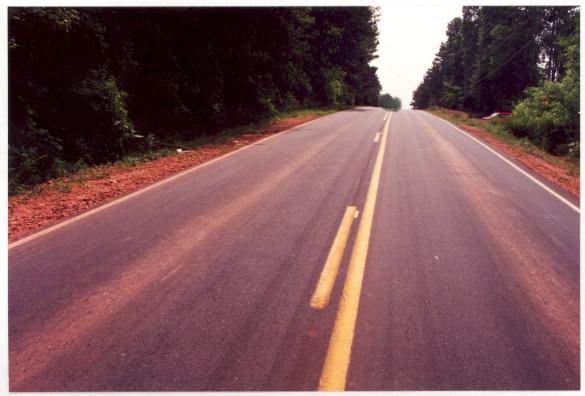
Path into impact and area of impact with the 1986 Pontiac Grand Am.

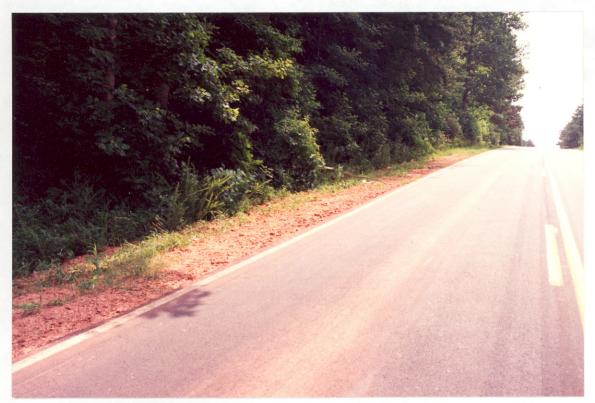
3. Path of Capri from impact with the Grand Am to impact with the road edge embankment and final rest.

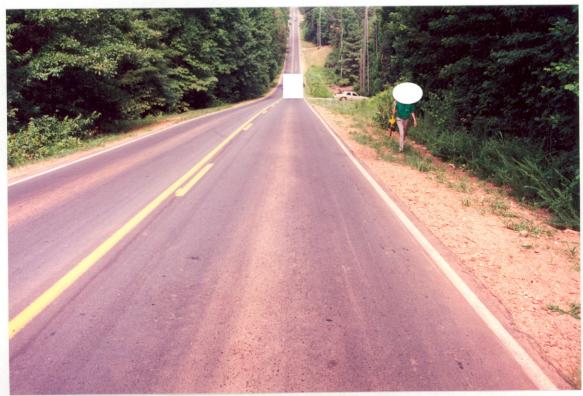
Opposite view from beyond impact with the Grand Am.

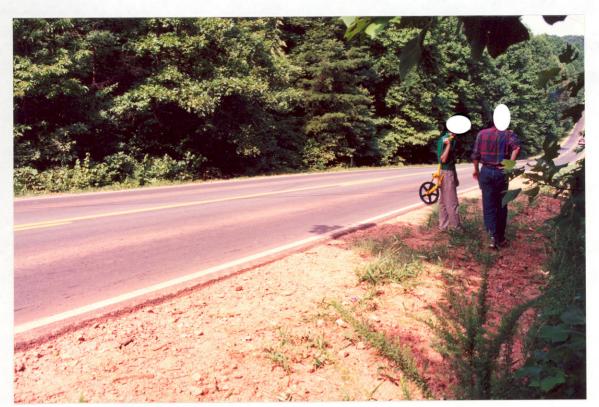
Opposite view from embankment impact and final rest.

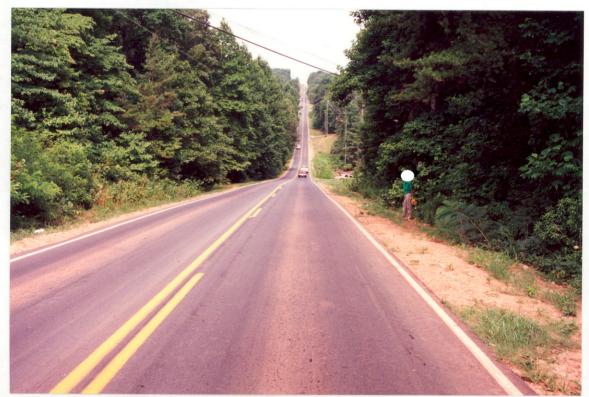
Pre-impact travel path of the 1986 Pontiac Grand Am west on Road.

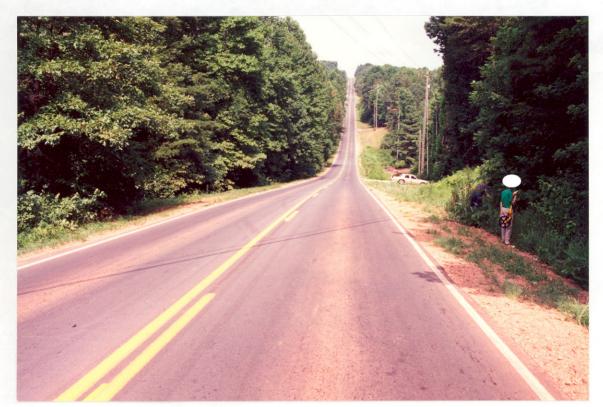
7. Path into impact and area of impact with the Capri.

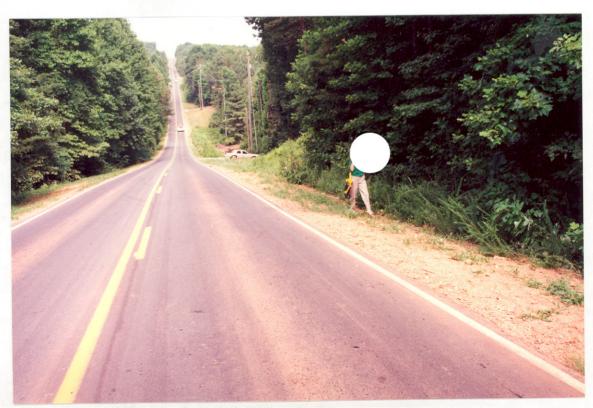
Path of the Grand Am from impact to final rest.

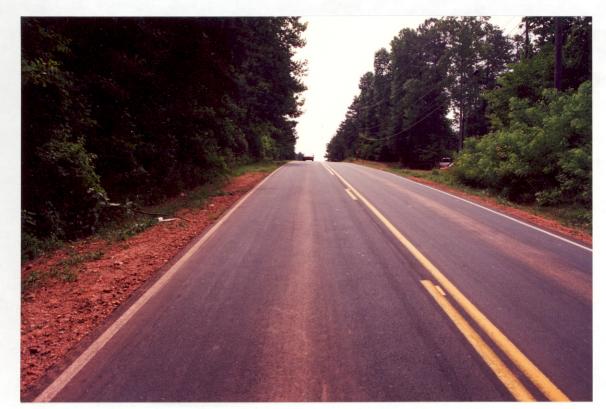
Opposite view from beyond impact.

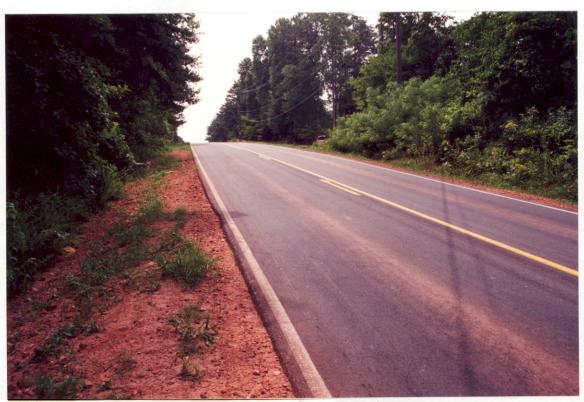
Opposite view from final rest.

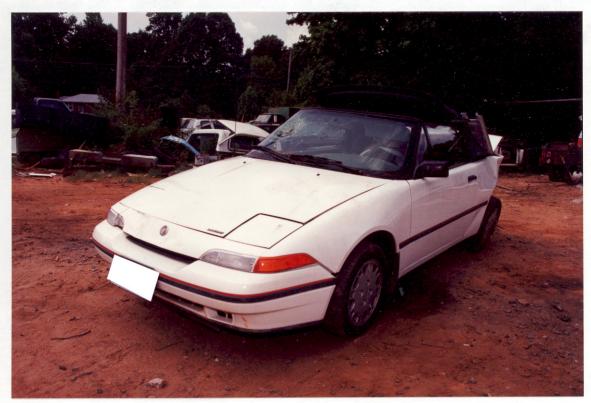
11. Front-left overall view of the 1991 Mercury Capri convertible (airbag vehicle).

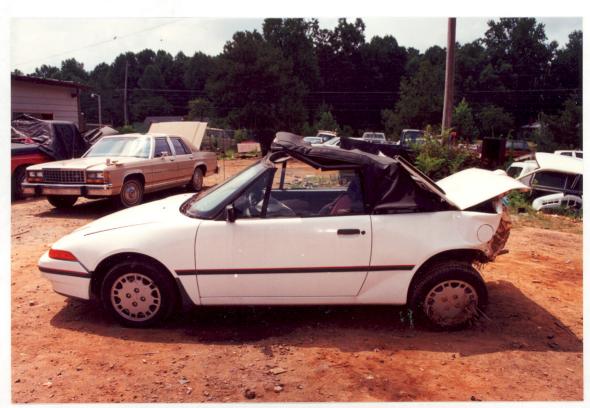
Left side view.

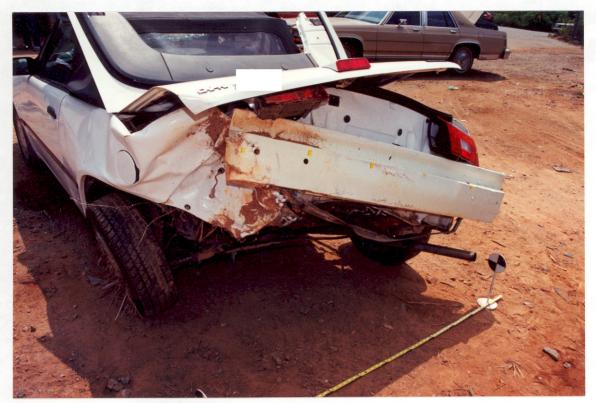
13. Rear-left view.

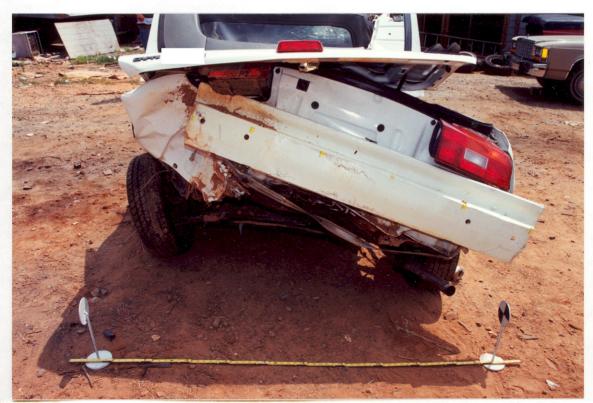
Rear view showing damage from impact with the embankment (impact #3).

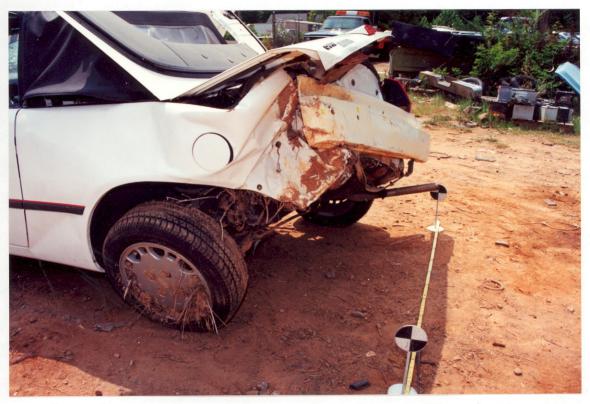
Second rear view of damage from impact #3.

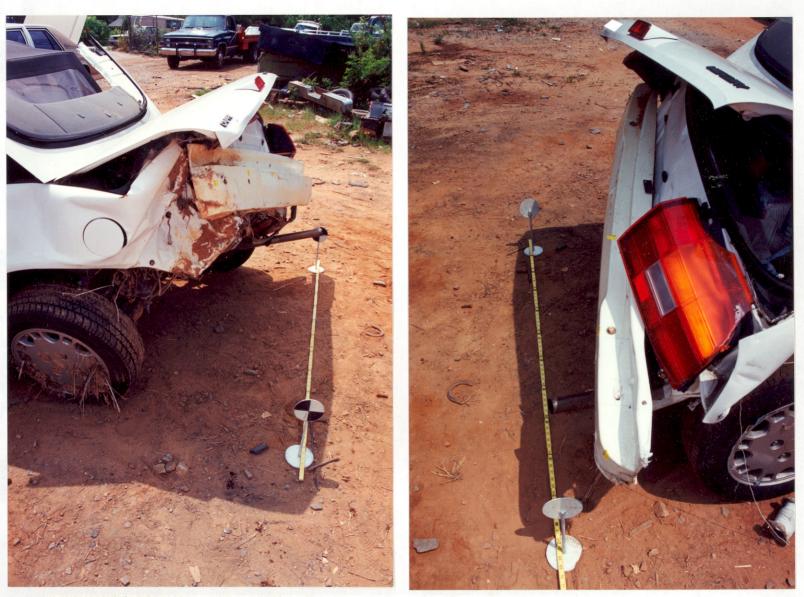
16-17. Views along rear stringline from the left side and right side.

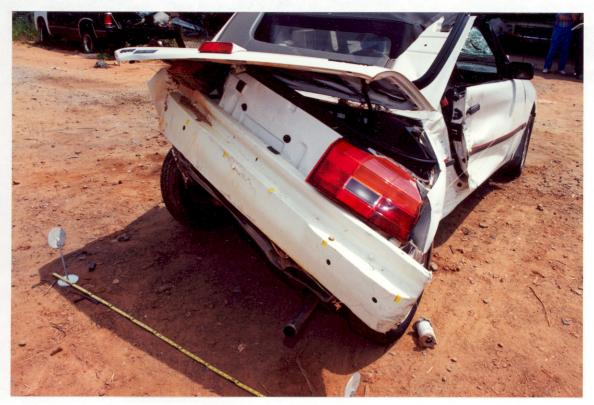
18. Rear-right view.

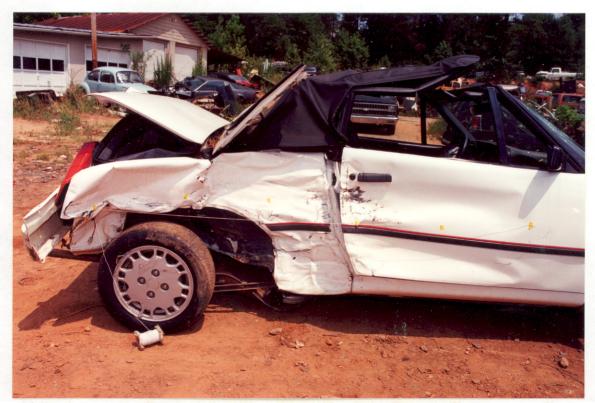
19. Right side view of damage from first impact with the Grand Am.

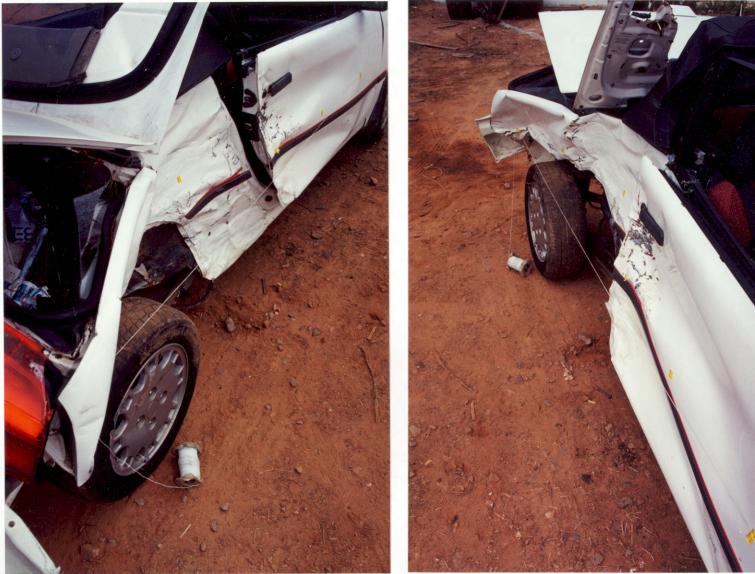
20-21. Views along the right side plane showing crush from the first impact with the Grand

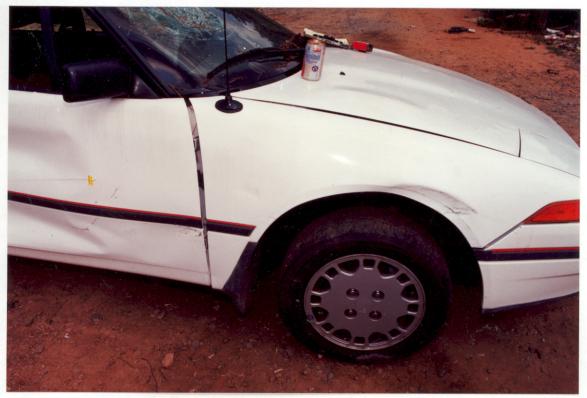
22. Right side view showing damage from the sideslap with the Grand Am (impact #2).

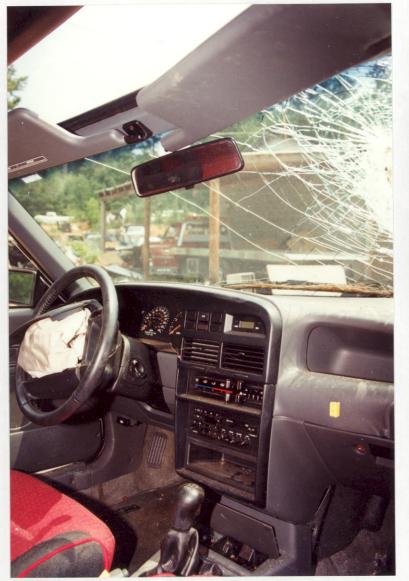
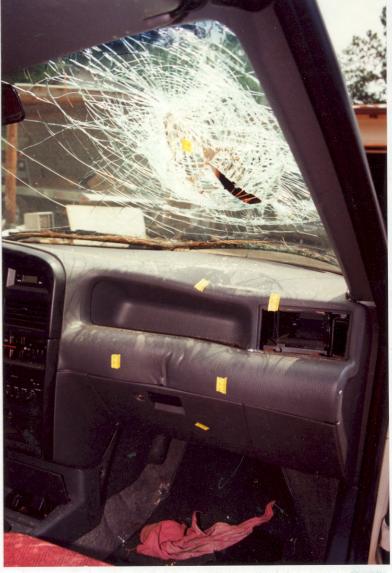
23-24. Interior views showing obvious occupant contacts to windshield and right instrument panel.

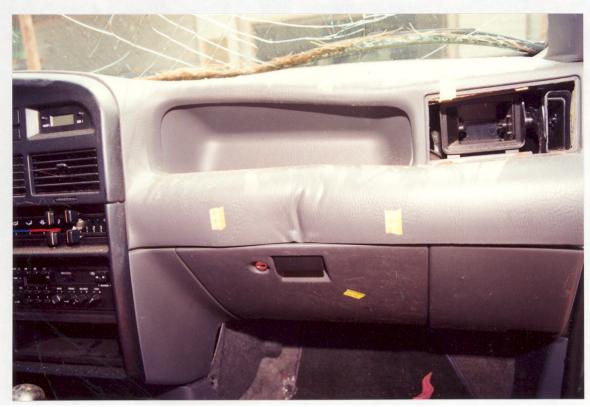
25. Right instrument panel showing obvious occupant contact points.

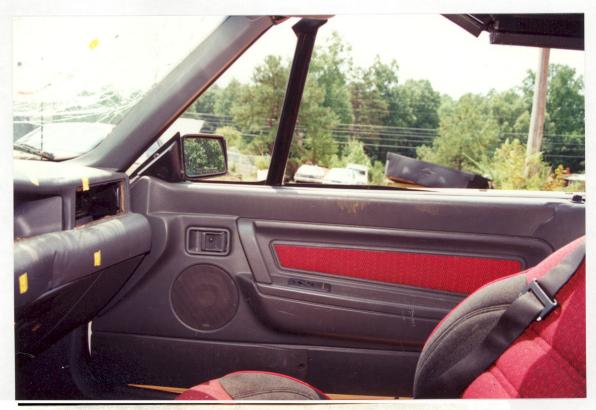
View of right instrument panel and right door.

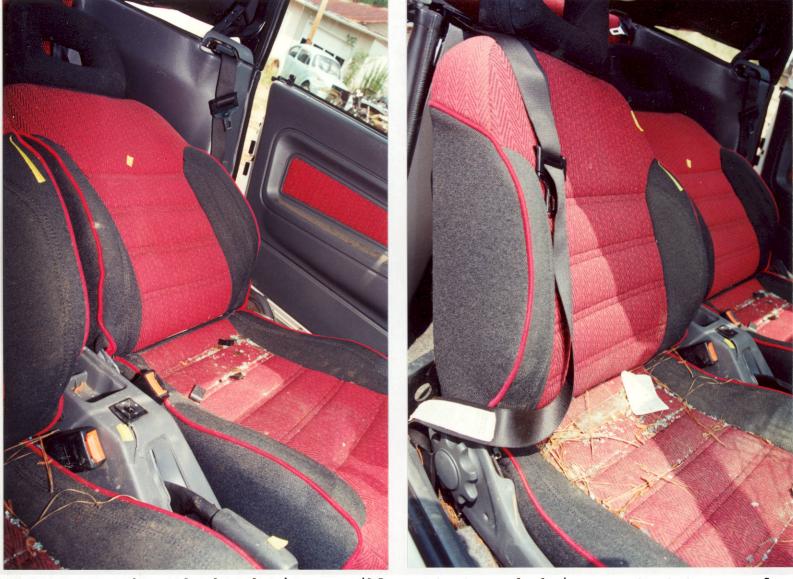
27-28. Front seats and seatbacks showing possible contacts and obvious contact to console.

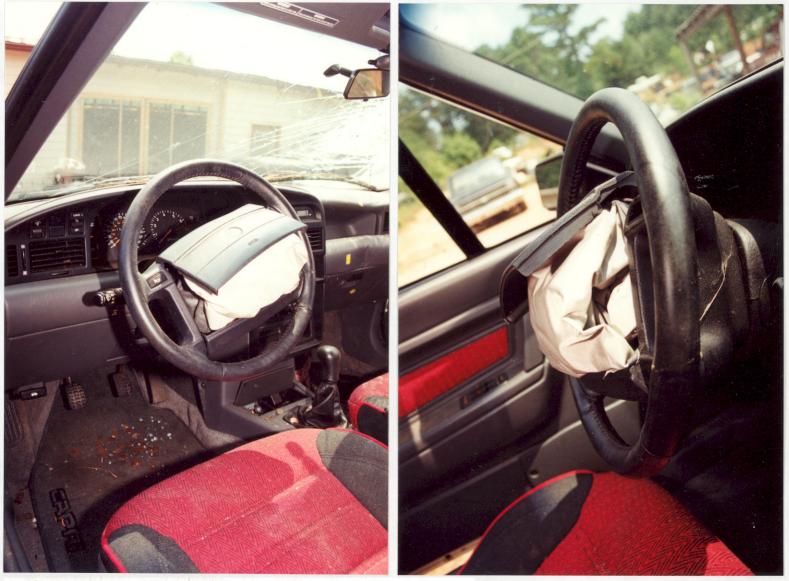
29-30. Views of airbag equipped steering wheel.

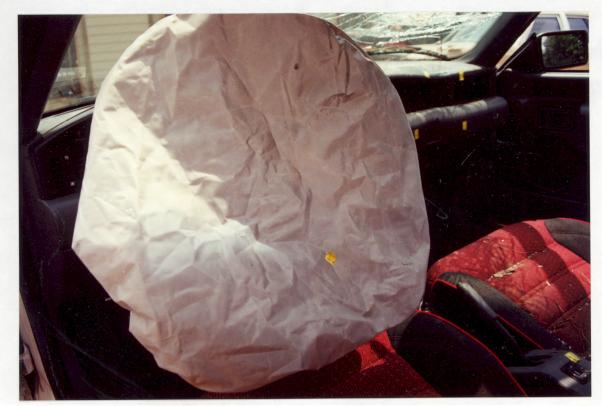
Overall view of deployed airbag showing possible occupant contact.

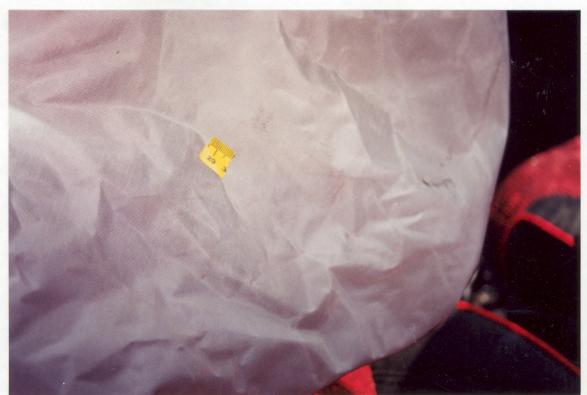
32. Closeup view of possible make-up transfer on deployed airbag.

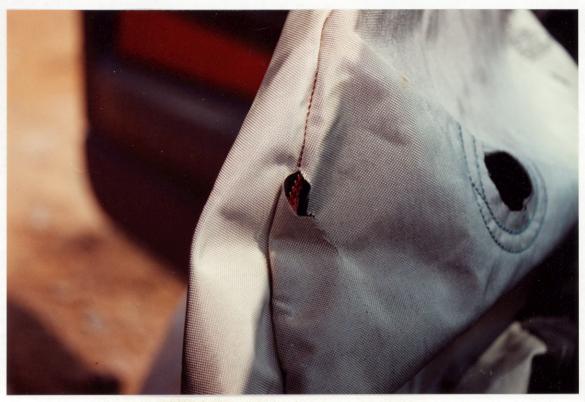
Views of slight tear in airbag material and unobstructed vent holes in the back of the airbag.

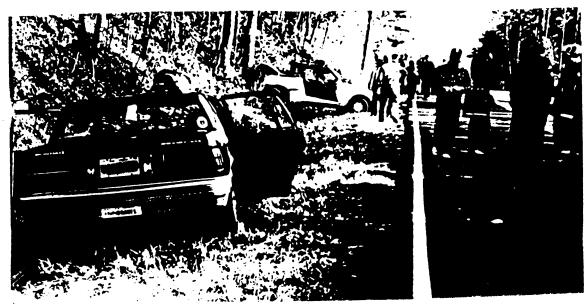
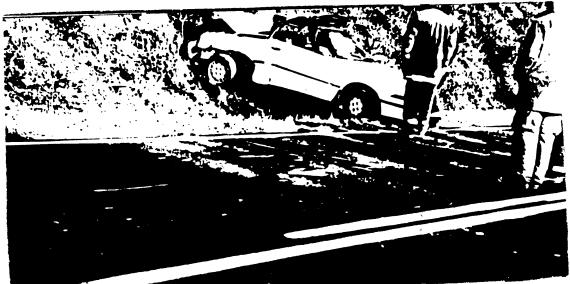
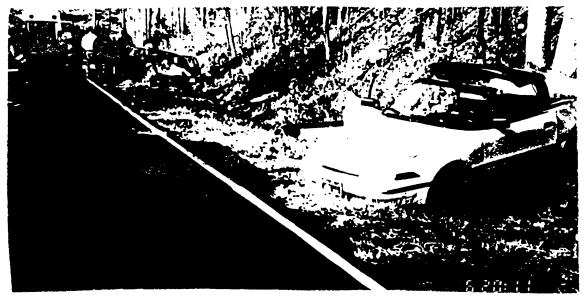
Photos of the 1991 Mercury Capri convertible (light colored vehicle) and 1986 Grand Am (dark vehicle) at final rest.

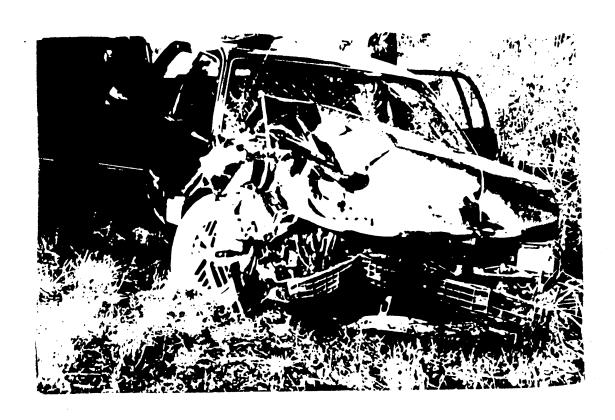
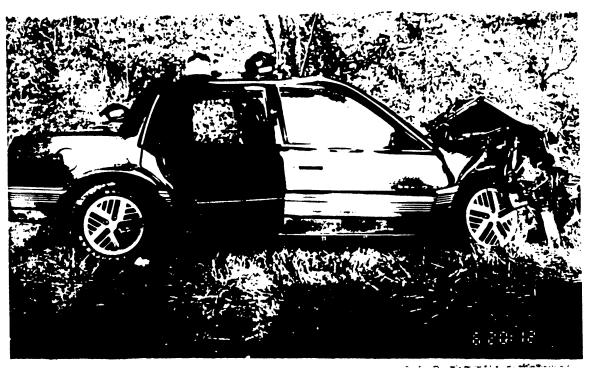
Photos of damage the Grand ${\bf Am}$. These are copies of the police photos taken at final rest.
